RESEARCH FINDINGS 2011

Revegetating harsh environments: lime and cement kiln dust residue areas

KATINKA RUTHROF • JOHN TOFT*

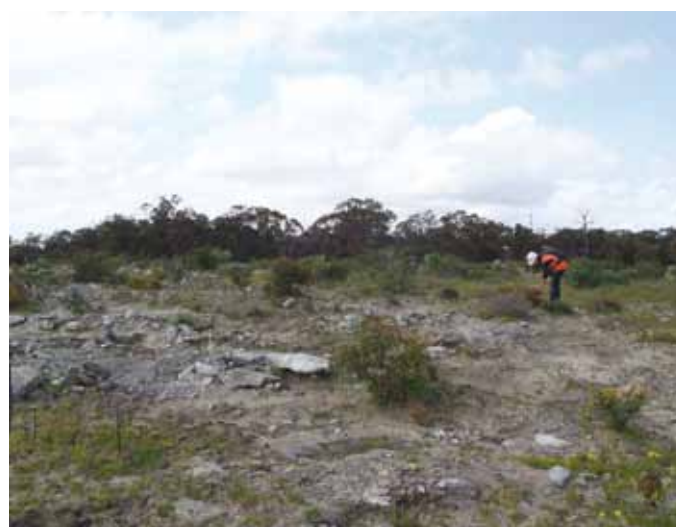
Figure 1 LKD revegetation site with Tegan Douglas.

Lime and Cement Kiln dust (LKD/CKD) are by-products of the lime and cement making processes. These products are mixed with water to produce slurry and deposited into residue areas. Quarry 5 Upper is a LKD and CKD residue area situated north-east of the Cockburn Cement Ltd. Munster plant. This quarry was revegetated in 2009 to reduce dust, increase aesthetic amenity, increase biodiversity, and increase habitat for fauna (see Figure 1).

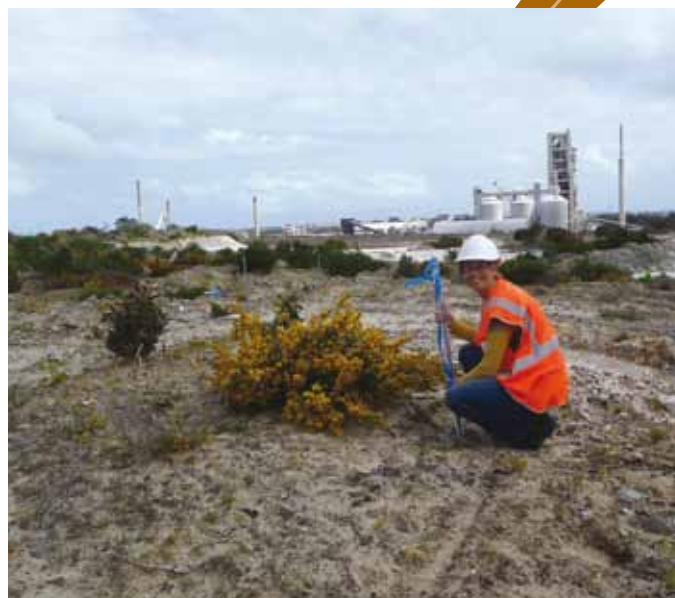
Figure 4 A higher proportion of vegetation survived at the LKD site than is usual for this type of revegetation project. This image shows a flowering acacia being monitored by the author.

A high plant survival rate (number of plants as well as species) was recorded: approximately 80% of seedlings planted survived the first year since planting (see Figures 3 and 4). The high survival rate was unexpected given a number of factors, including: the low amount of topsoil on top of the LKD, the lateness of the planting (July, rather than June), the unusual frost events that occurred following planting, and the 2009/2010 summer being one of the longest and driest summer periods experienced in Perth for many years.
